Monitoring Report

Visit Date	20-10-2016
Report Submitted	18-11-2016

- 1). **Name of Project:** GGHS Hooran District Bhimber
- 2). **Sector:** Education
- 3). **Sub-Sector:** E&S Education (High)
- 4). **Unique Ref. No:** ESE-186
- 5). **Location:** Hooran

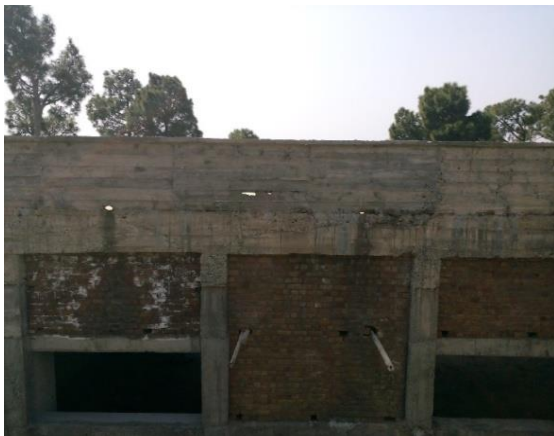
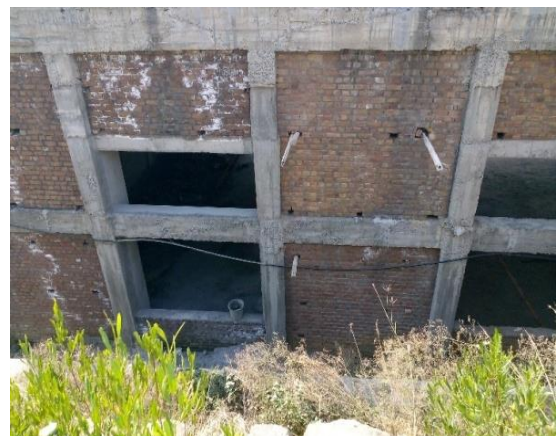
- i. This project is part of “Acquisition of Land, Construction of Buildings and Provision of Furniture for 6 new High Schools of District Bhimber (revised) costing Rs.238.740 million. It is total discretion of the Executive Engineer to which sub-project he wants to doze more.
- ii. Work schedule was not found available with the executing staff nor has its allocation been conveyed to the executing staff.
- iii. Honey combing has been observed in the beams of rooms and columns of hall due to not use of vibrator during pouring of concrete.

- i) Skilled labor should be hired to improve the quality of work.
- ii) Defects must be removed.
- iii) School land should be protected by demarcating the Jungle.

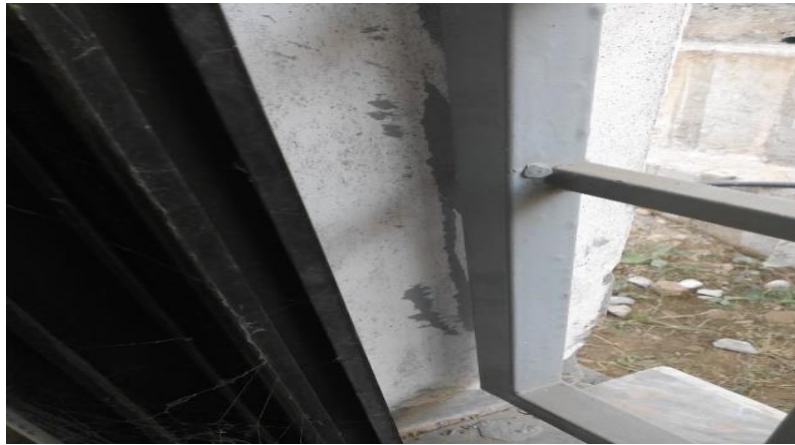
Gap has been observed between the window frame and wall of a room because of non-verticality of wall and its plaster.

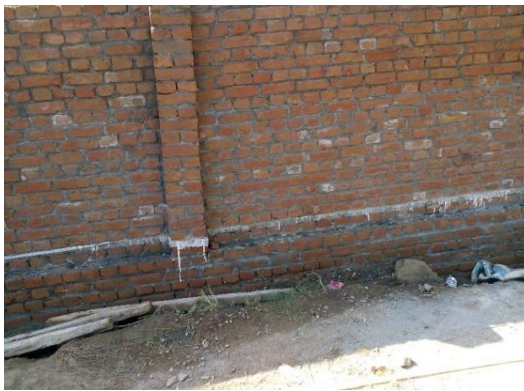
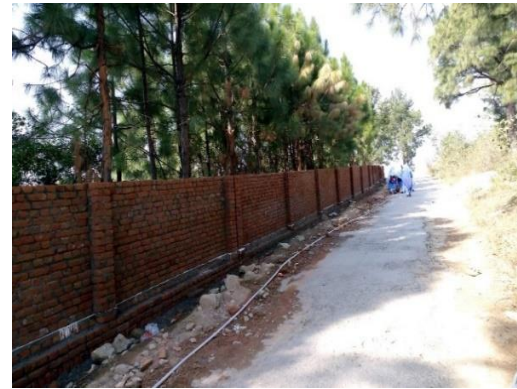
Poor workmanship of masonry in the Boundary wall has been observed as neither the bricks are laid horizontally nor vertically in a course. Shop drawings of the items to be manufactured are not available and approved by the Engineer in charge.

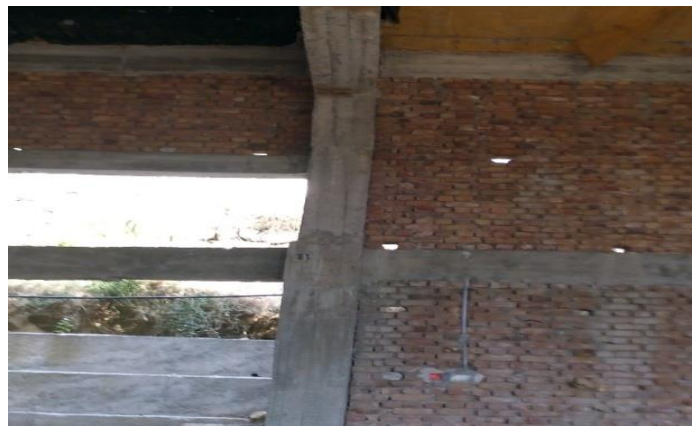
Poor workmanship in formwork of columns of hall has been observed.

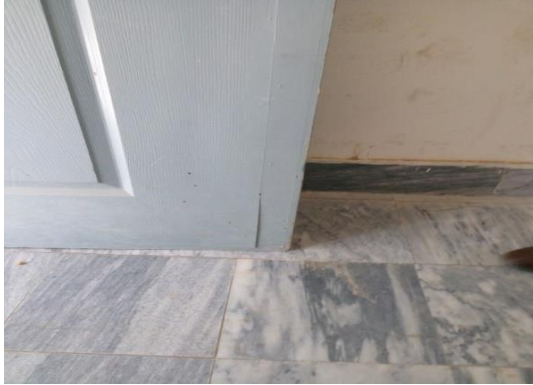
Ply door surface has been disturbed at its erection phase.

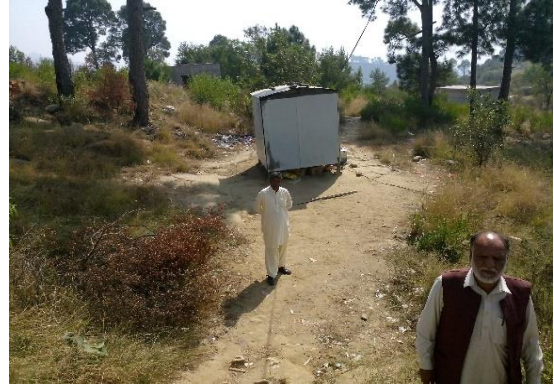
Encroachment in the school land has been observed by a local as a result of a temporary shop (Khoka).

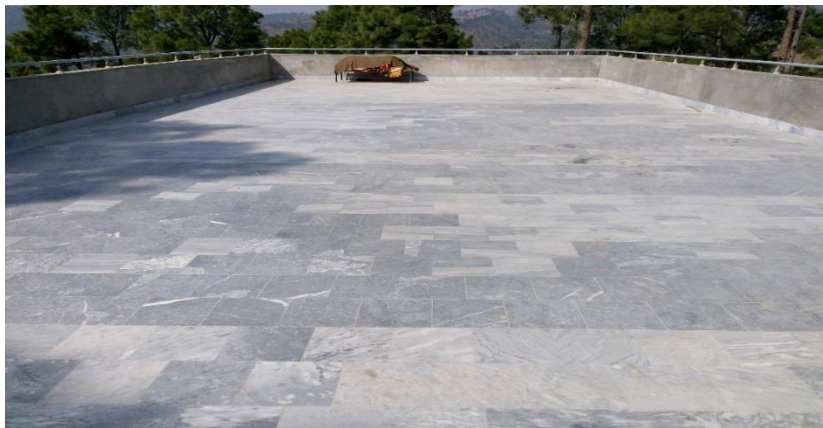
Marble tiles on slab roof of a room has been executed instead insulation. In the BoQ, roof insulation has been proposed.
