Monitoring Report

- 1). Name of Project: GGHS Khadoora District Bhimber
- 2). Education Sector:
- 3). Sub-Sector: E&S Education (High)
- 4). Unique Ref. No: ESE-186
- 5). Location: Khadoora

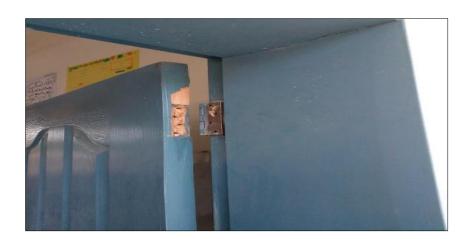
- 7. Main door of the school, doors of lab and store have been damaged at hinges. Ply doors shutters exposed to rain have also been damaged by absorbing water. Ply doors should have not been proposed where they are exposed to rain.

Photographs 1-5 below clearly show the deteriorated positions

Doors do not serve the purpose for which it have been provided. All the expenditure have gone

to waist.

- 1. Damaged doors should be replaced.
- 2. Toilet block is required to be rehabilitated.
- 3. Seepage in the slab and walls of the hall must be prevented.
- 4. Remaining work of Boundary wall must be completed.
