Monitoring Report

Visit Date	03-08-2016
Report Submitted	03-10-2016

- 1). **Name of Project:** Acquisition of Land & Construction of Sports Stadium at Pallandri
Sector: Sports Youth & Culture
- 3). **Sub-Sector:** Sports Youth & Culture
- 4). **Unique Ref. No:** SPO-136
- 5). **Location:** Pallandri

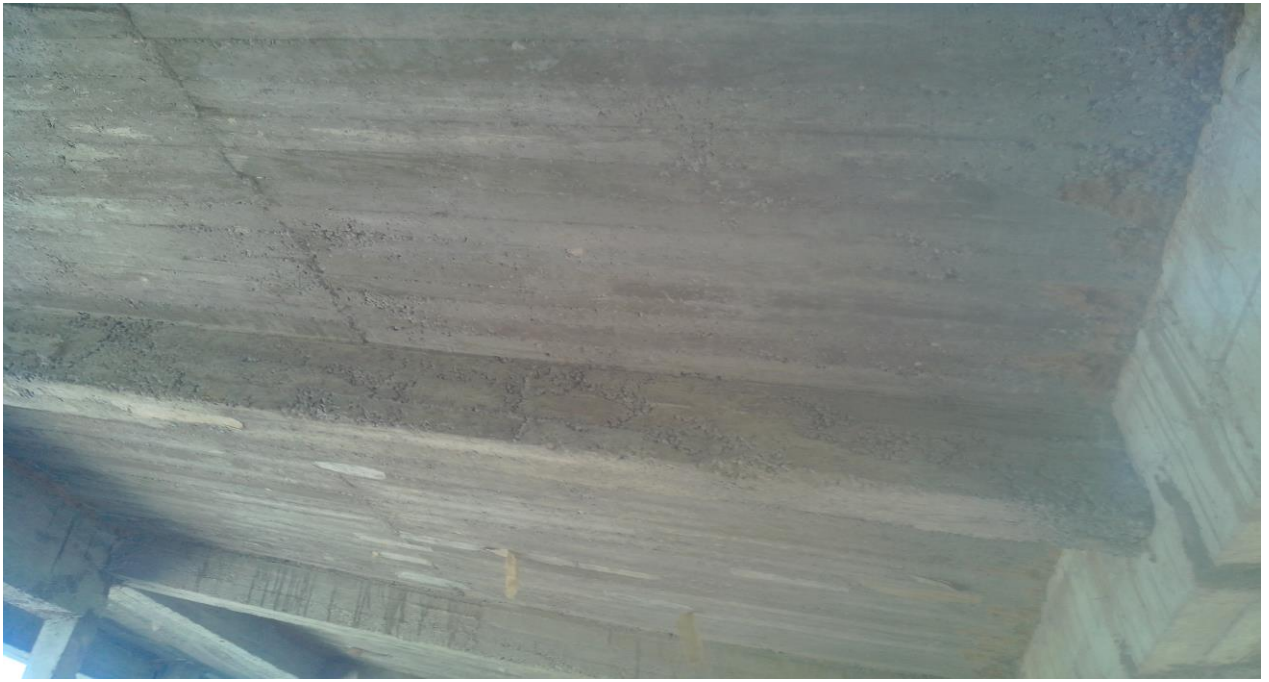
5. Quality of brick masonry work was very poor.

5. Quality of civil works was found poor as mentioned under the head findings Sr.No.5-8. Responsibility should be fixed for poor quality of work.

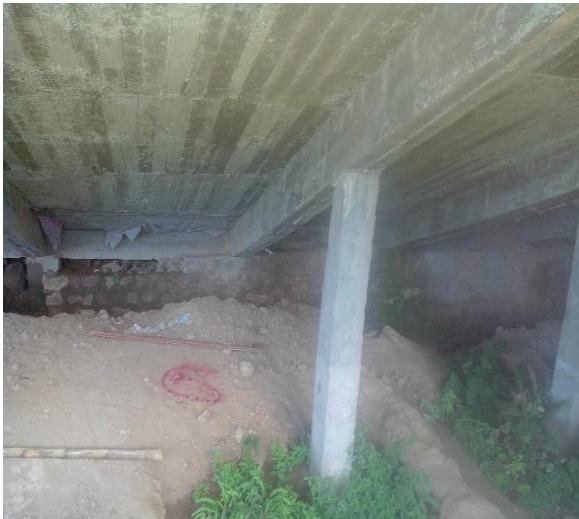
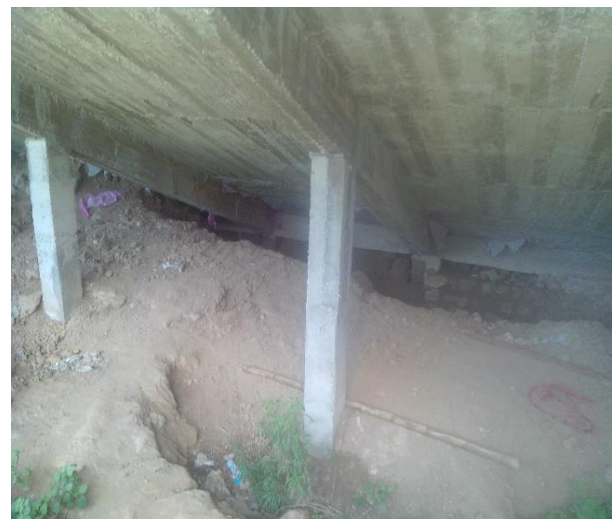
6. Honeycombing was observed in beams, columns and slab which shows the poor quality of workmanship.
