Monitoring Report

Visit Date	03-03-2016
Report Submitted	17-05-2016

- 1). **Name of Project:** Development of Dheerkot Tourist Resort
- 2). **Sector:** Tourism
- 3). **Sub-Sector:** Tourism
- 4). **Unique Ref. No:** Tou-103
- 5). **Location:** District Bagh

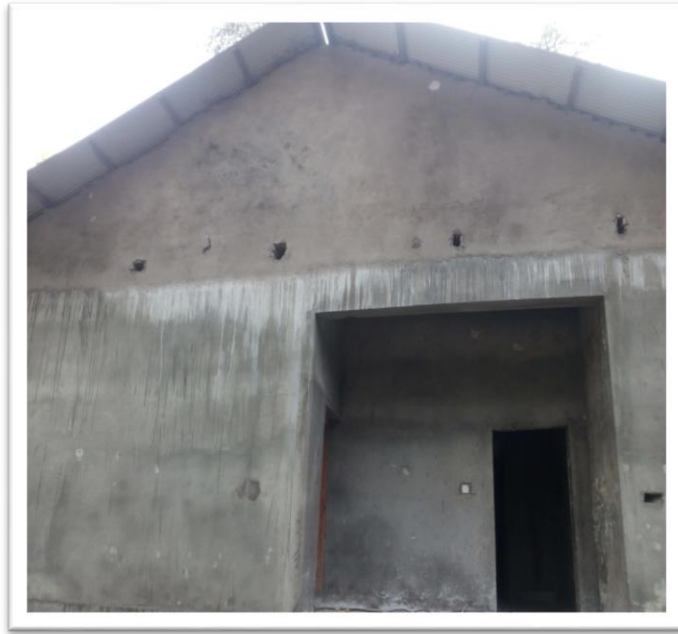
Side view of motel

The outlined portion shows maroonish texture which indicates the use of sub-standard sand with considerable %age of clays which is not recommended

6. Airing of the damaged particulars as mentioned in the findings should be done at the cost of contractor.
7. Honey combing and dampness should be controlled by using proper engineering techniques.

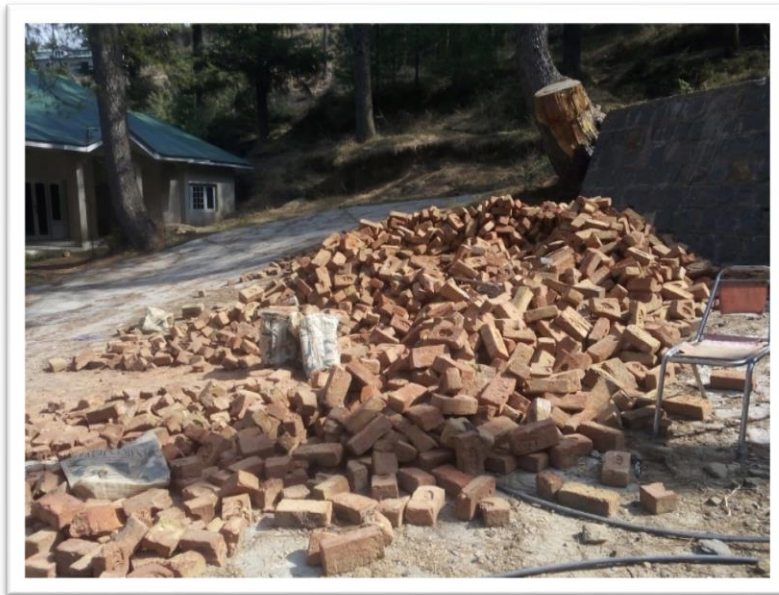
Use of substandard bricks was observed

No ringing sound was observed on field analysis, reddish color indicating grade-C brick usage in the construction.

12. The technical staff should regularly monitor all the activities to avoid use of sub-standard material and poor quality work.

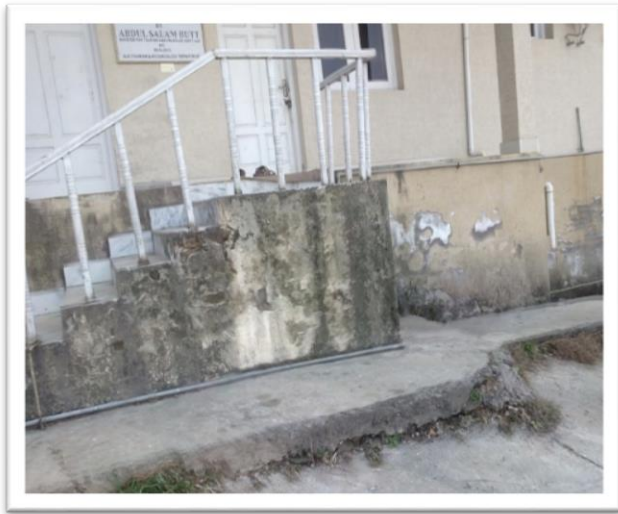
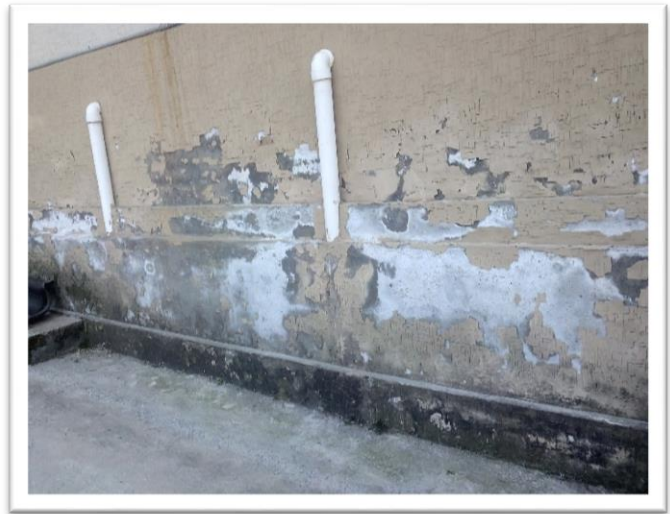
Due to dampness damage done to the walls of cafeteria building which indicates poor type of construction, indicating Alkali-silica reaction too as salts are precipitated on surface.

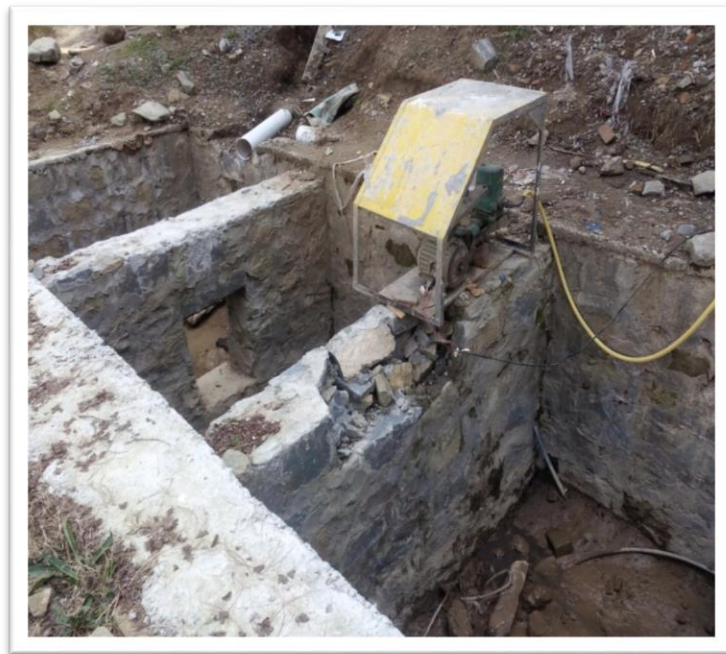
Damaged wall of the water storage tank due to poor construction. Use of very sub-standard material de-sedimentation needed

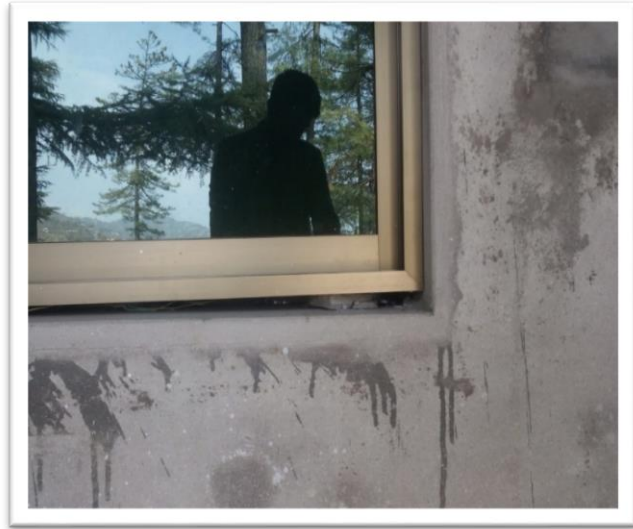
Poor Alignment of window

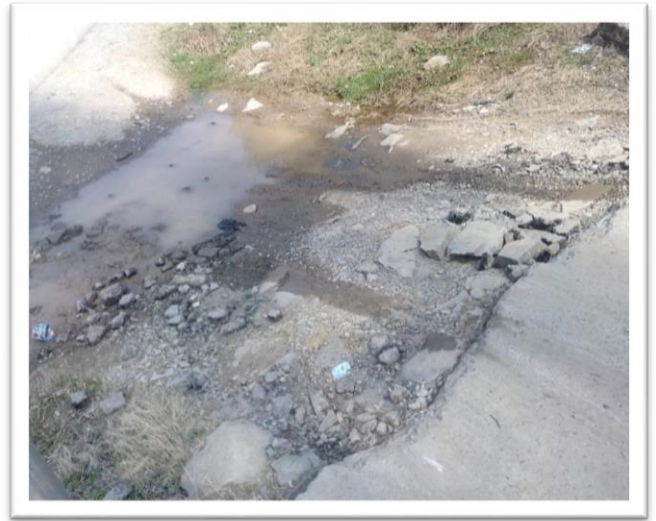
Access road is damaged due to poor water Management, x-drainage and culvert or causeway needed

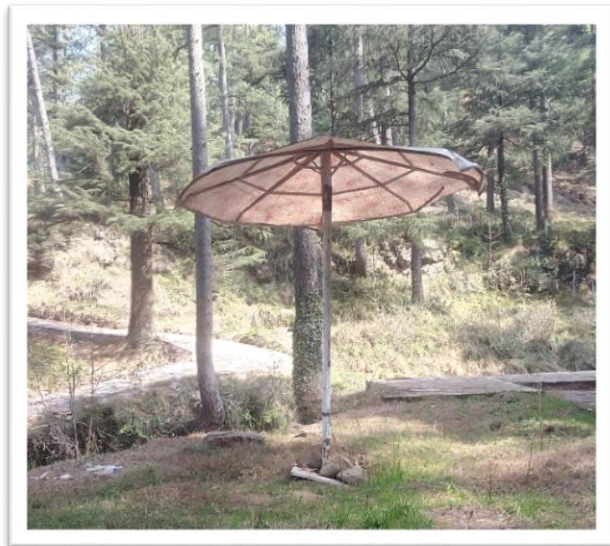
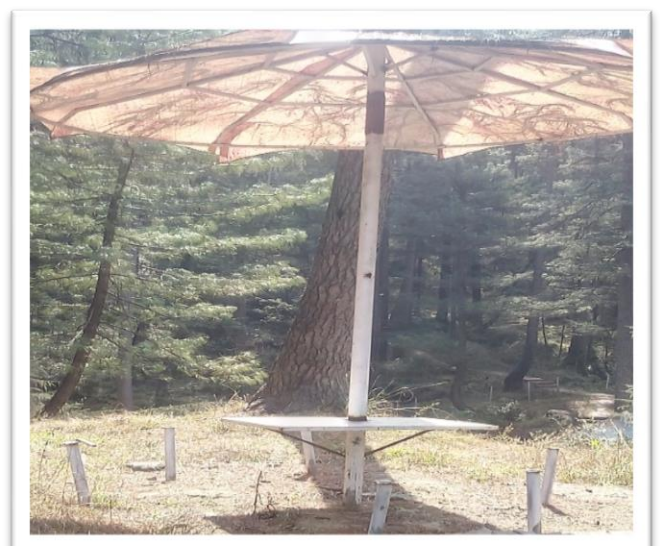
Damaged fiber glass canopy even before the execution of project

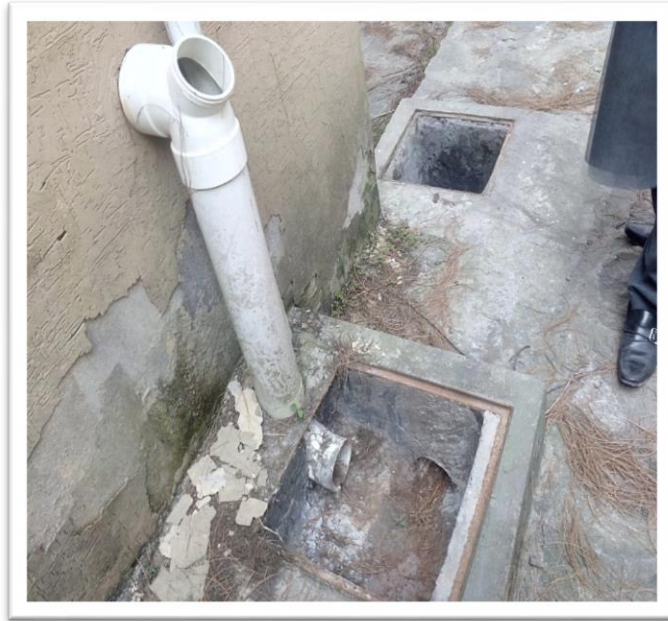
Water Geezers of dormitory are missing, open manhole and broken pipe indicates poor construction, management and look after of the project. Dampness also observed.

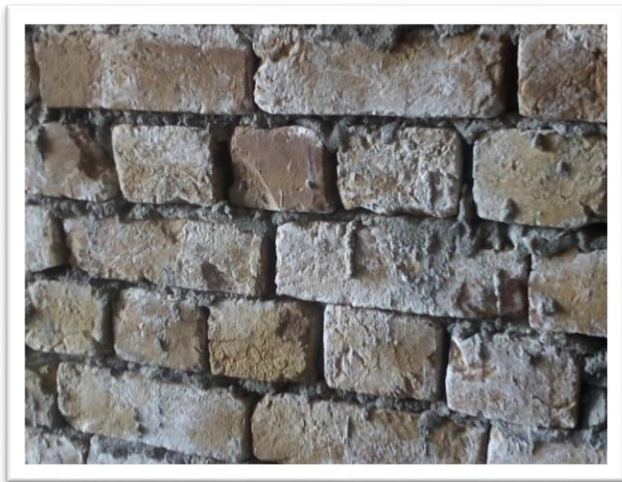
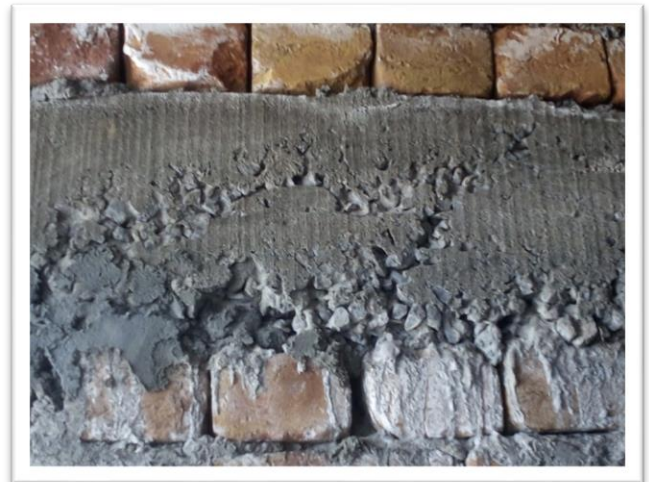
Sub-standard bricks with bloating observed, no strength was found upon filed analysis.

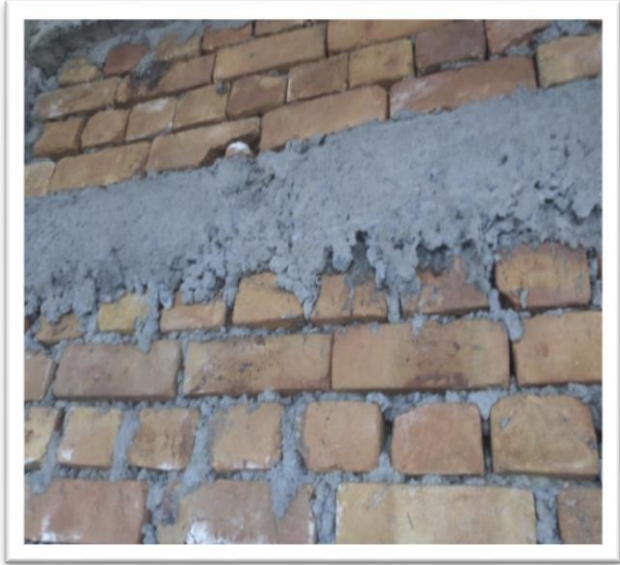
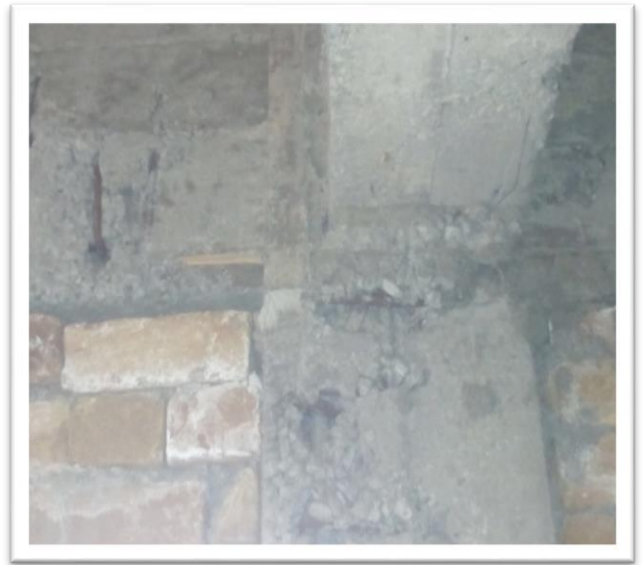
Example of Poor brick work. Sagging & honey combing observed due to poor finishing.

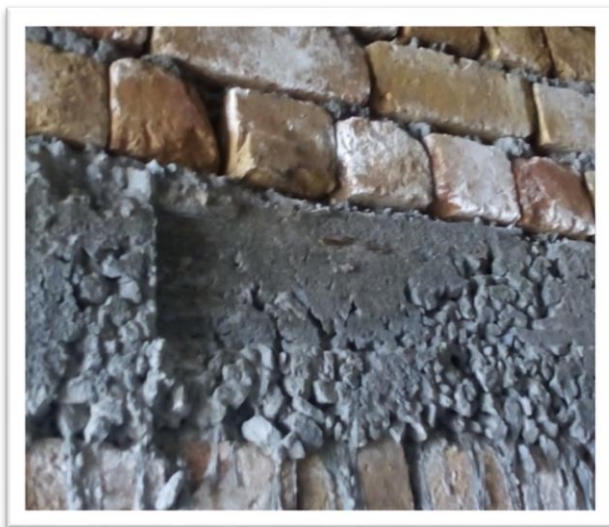
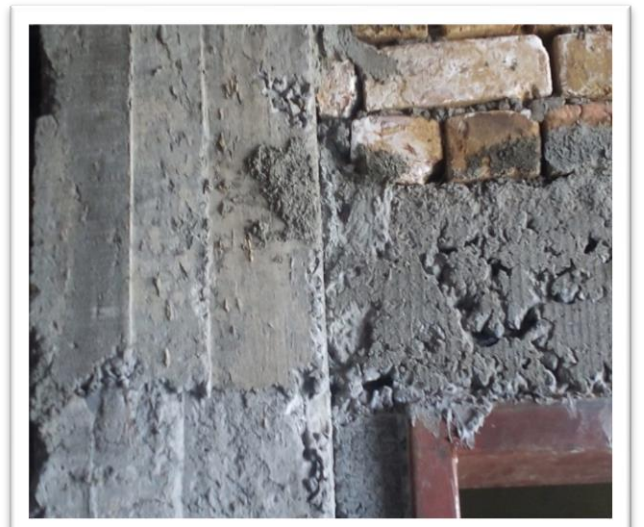
Use of substandard bricks was observed. Poor finishing, massive honey combing, sagging and exposed steel in beams were observed.
